GREENSHIELD  
TECHNOLOGY  
REPORT

2009

## **Waterwall Protection**

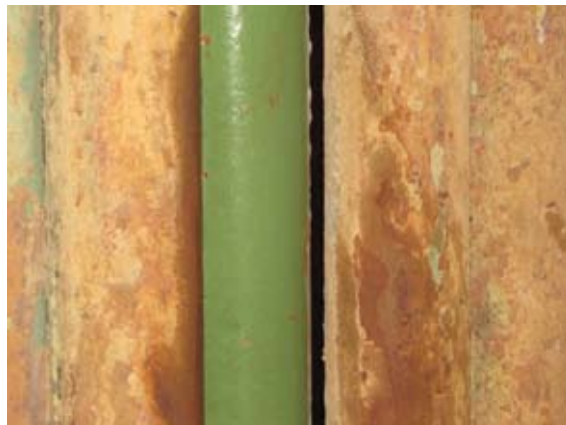
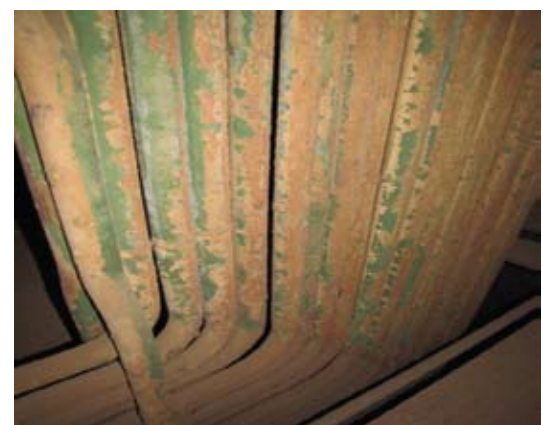
### After 2 Years in Service...

The application of GreenShield was completed in 90 hours and the coating demonstrated great success against slag adhesion and corrosive attack. In addition the GreenShield coating provided the boiler operator with a visual inspection tool to quickly determine where aggressive abrasion and corrosive attack was pronounced in the boiler.
